EXPERIENCES WITH  
THE “**CLEAN RETICLE HANDLING**” PATH  
TOWARDS HVM NEEDS

**RIK JONCKHEERE**

**@ IEUVI MASK TWG, 6 OCTOBER 2013**

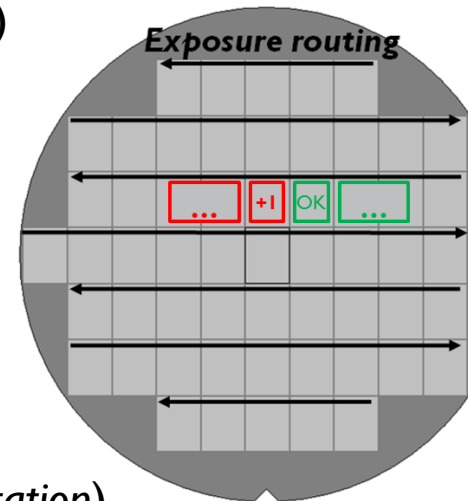
- ▶ **Evidence of occasional added particles during exposure and in between exposures (but inside scanner)**

- ▶ Target for clean handling must remain 0 adders
- ▶ In parallel to continuous scanner improvement, ASML is studying feasibility of a pellicle solution (see next presentation), to assure no yield loss is caused by printing adders
- ▶ ***If 0 adders cannot be assured, what is a tolerable front-side adder rate ?***

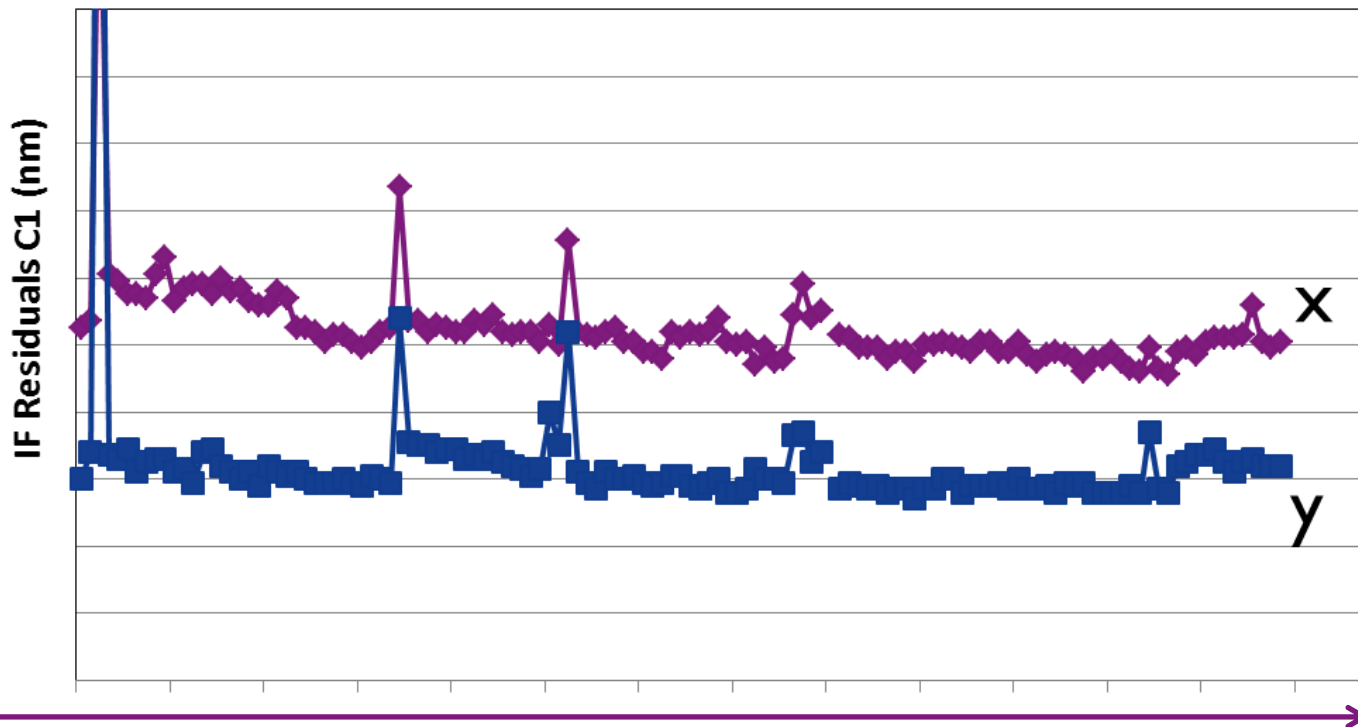
... has reduced the impact and frequency of BS particles causing printed overlay excursions

Time line since NXE3100 is @imec

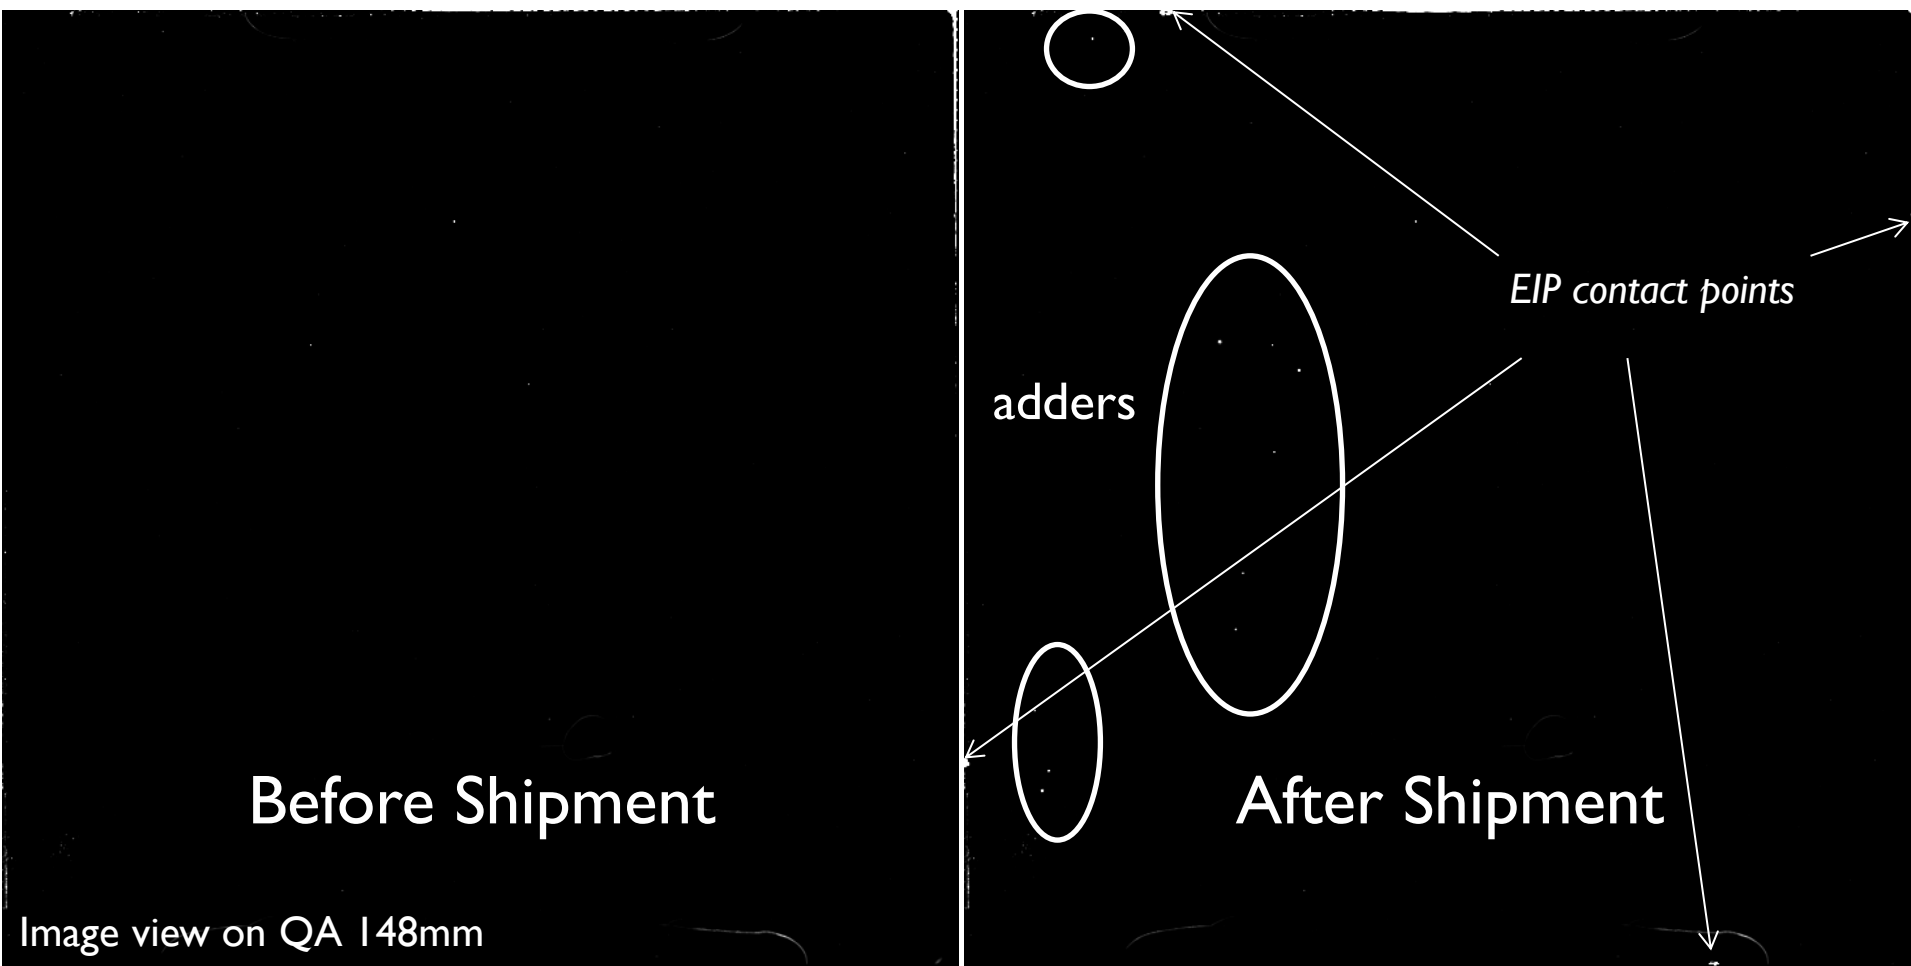
pod type	do what		<---- Adders BS ----->		
	imec-Entegris-imec	<b>BACK-SIDE</b>	>20 $\mu$ m	5 - 20 $\mu$ m	$\leq$ 5 $\mu$ m
new 1007A	ship + ISTA-3A protocol		0	3	12

Before Shipment

After Shipment

Worst case

**Very encouraging results → found OK to use for shipping,  
but recommending cleaning upon arrival to cope with few residual adders**

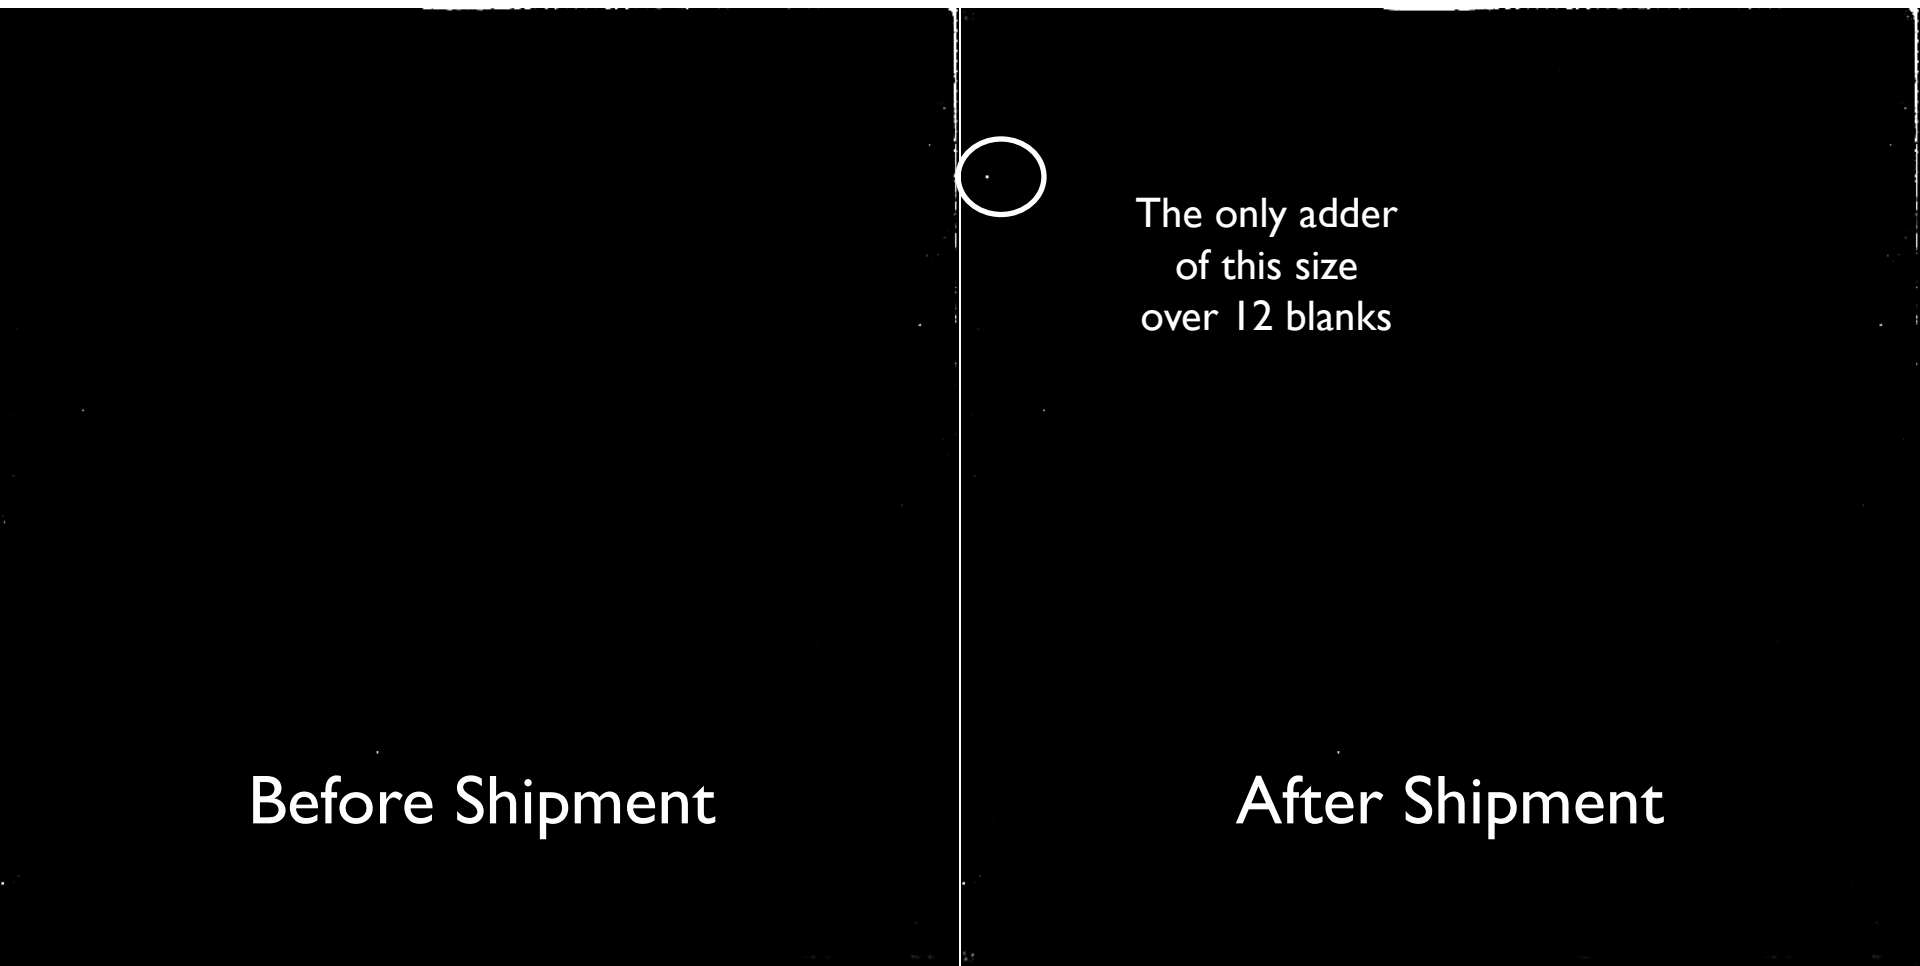
Worst case

Image view on QA 148mm

pod type	do what	Adders FS		FRONT-SIDE
		>0.5µm	<0.5µm	
	imec-Entegris-imec			
new 1007A	ship + ISTA-3A protocol	1	0
