EUV Mask Contamination During Use

(A presentation at the IEUVI Optics Contamination TWG)

Ted Liang
Components Research
Intel Corporation
10/02/2008

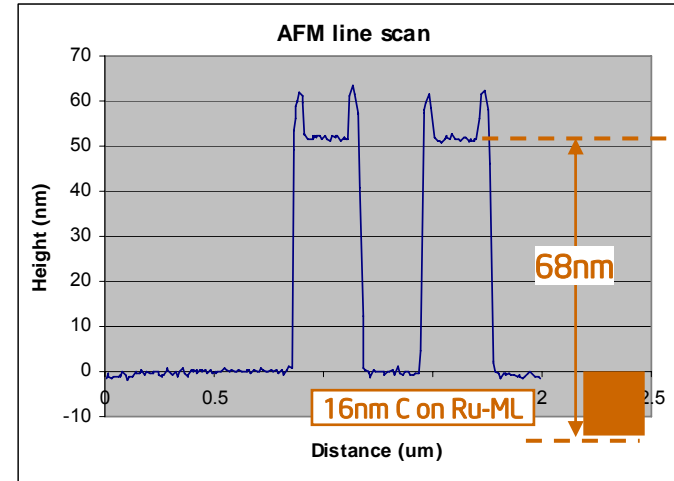
AFM on Contaminated Die - 40nm Elbows

- **At least 16nm thick C build up**

- Pattern height $\sim 52\text{nm}$ ($\Delta t = -16\text{nm}$)
- Contamination on Ru-surface remained after SC1
- Some contamination remained on AR-TaBN after SC1

- **'Rabbit ear' on pattern top: $\sim 10\text{nm}$ (from 16nm)**

- Contamination on pattern edge remained after SC1
- Different characteristics? - TaBN vs. AR-TaBN, high SE

- **Contamination on pattern top**

- Most was cleaned off with SC1
- Remaining patches $\sim 16\text{nm}$ thick

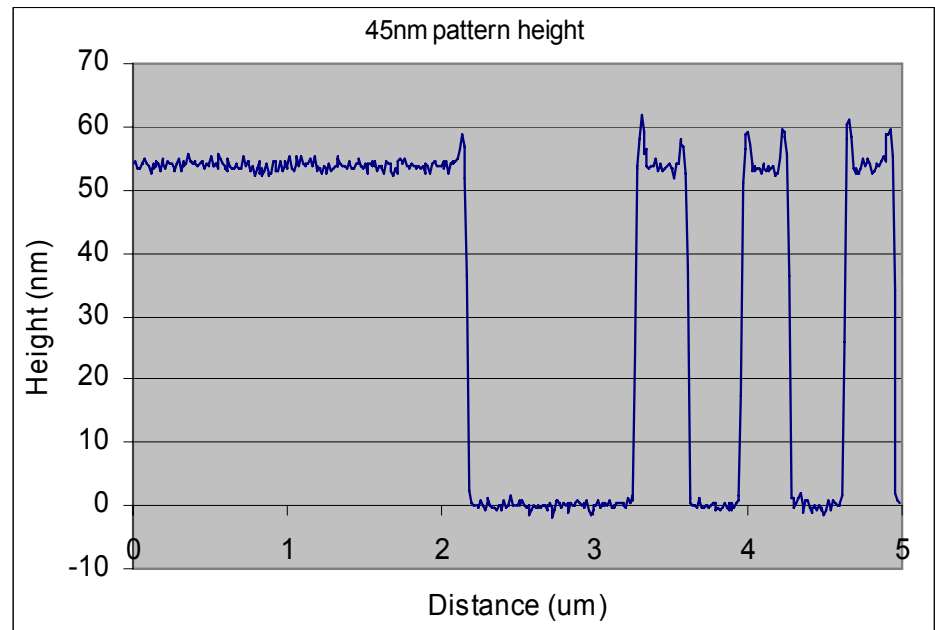
45nm elbows on contaminated die

■ Same observations

- Pattern height $\sim 52\text{nm}$ ($\Delta t = 16\text{nm}$)
- Same "Rabbit ear" on pattern top

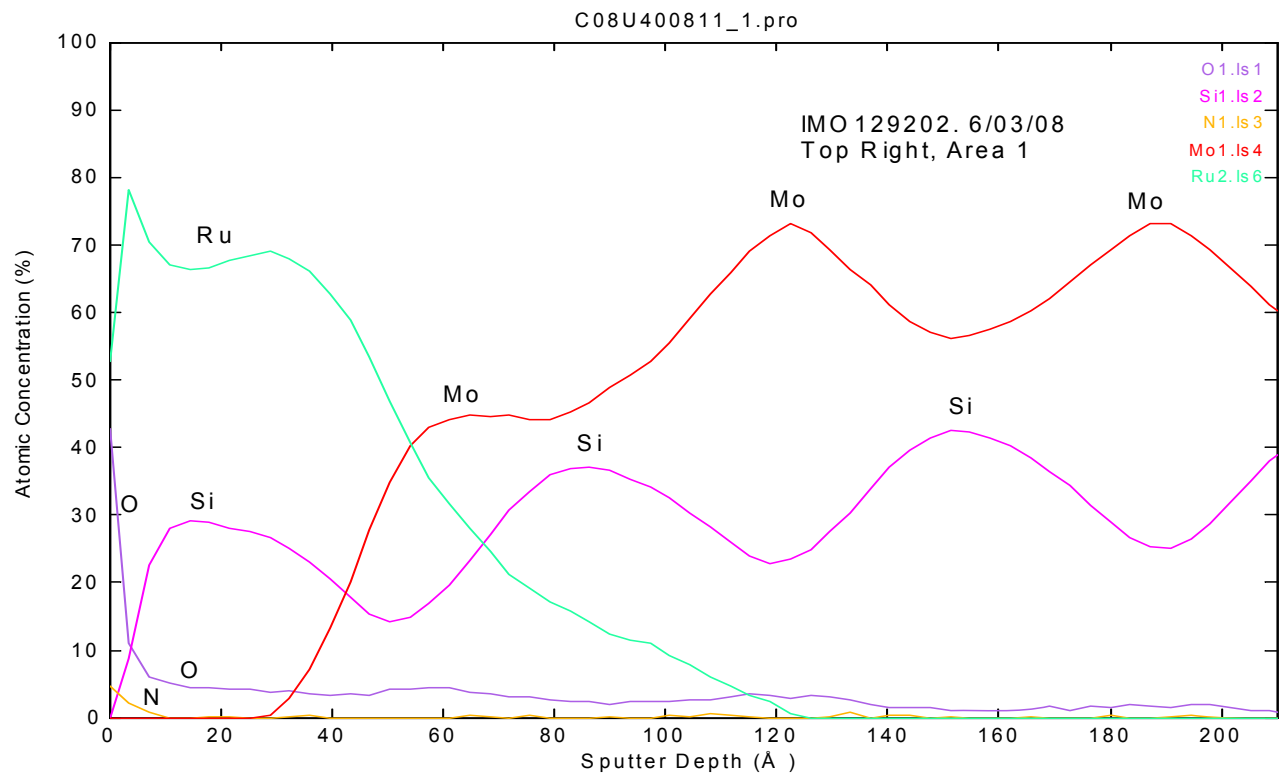
- On Reference (non-contaminated) die, Area 1 (Ru-ML)
- Typical of a normal mask with Ru-ML blank

Note: Ru sputtering rate not calibrated

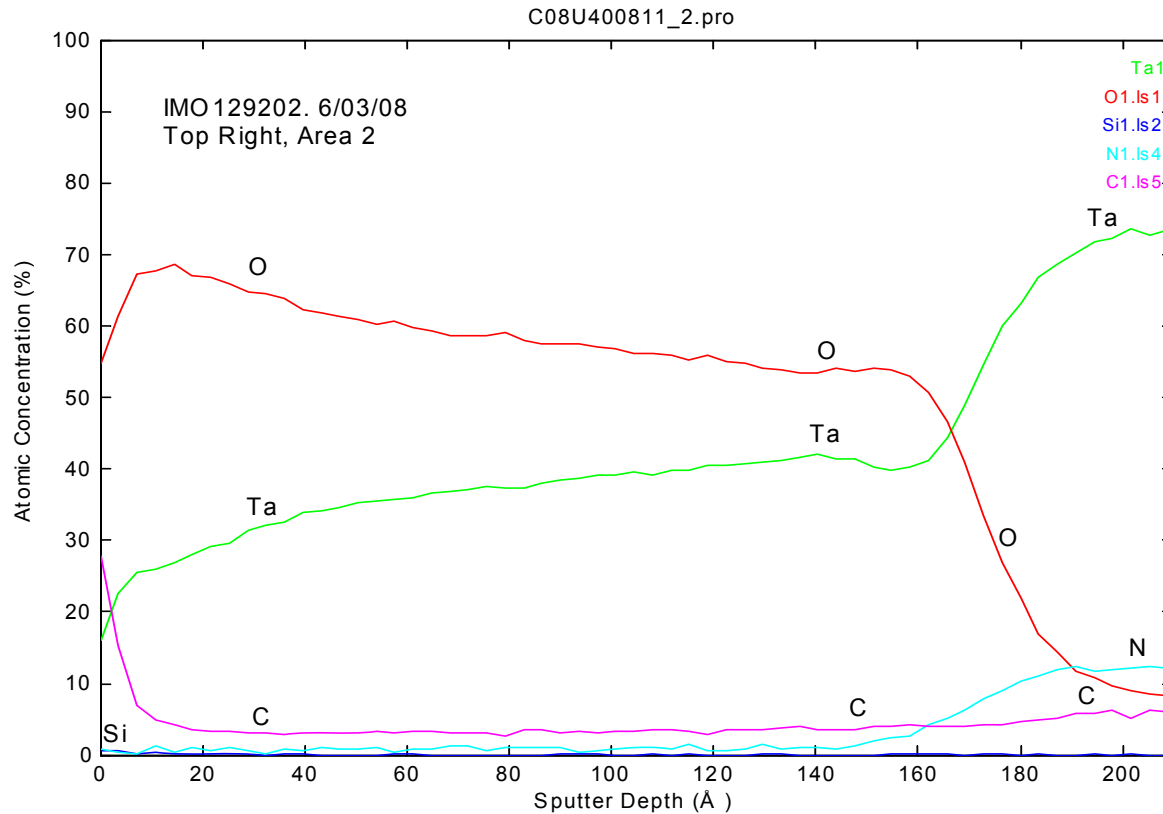
- On Reference die, Area 2 (LR_TaBN absorber)
- Typical of a normal mask with ARC-TaN based absorber

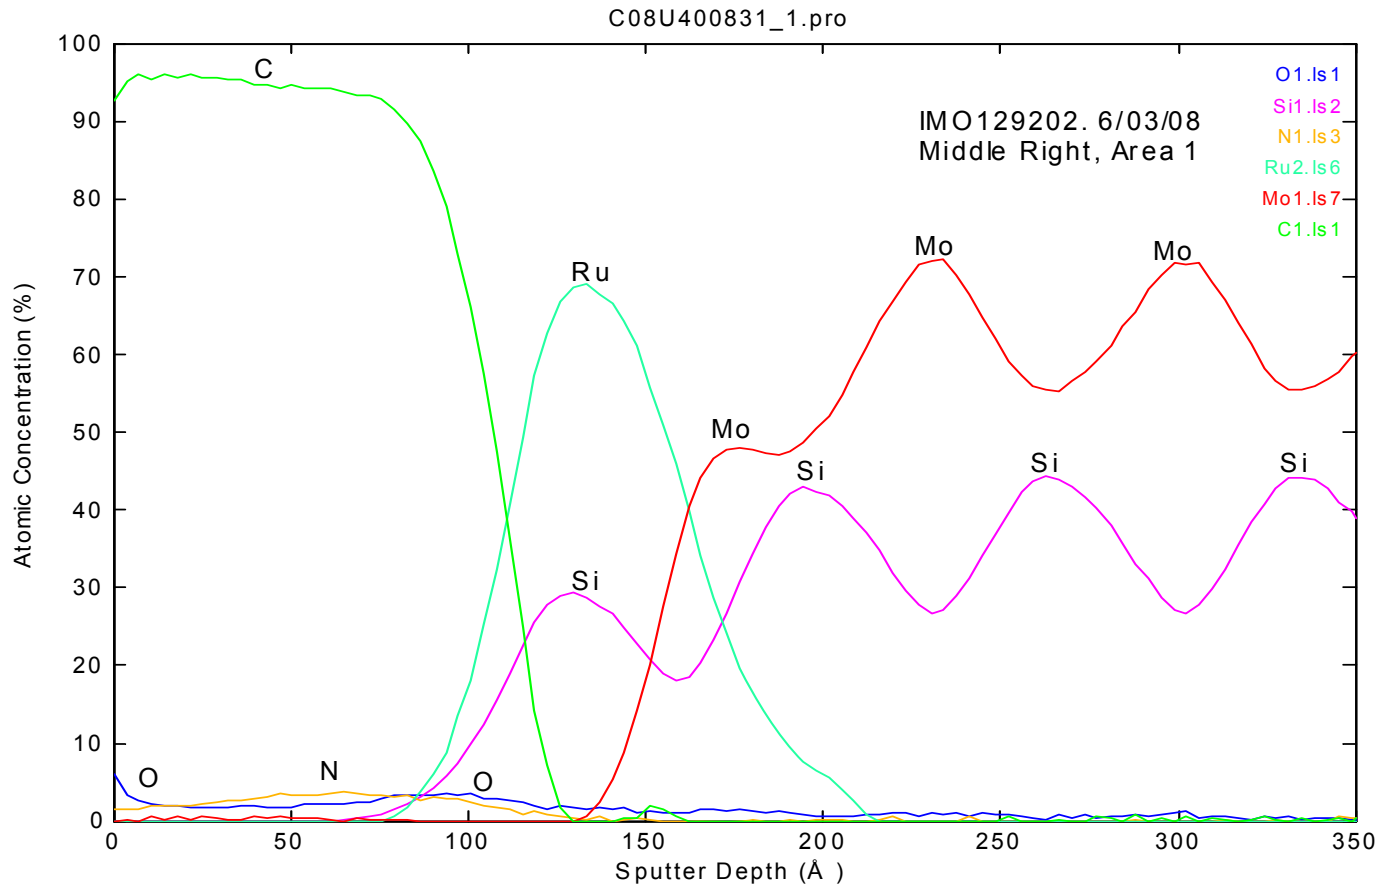
- On Contaminated die, Area 1 (Ru-ML)
- Surface was completely covered by C contamination
- No significant O signal increase

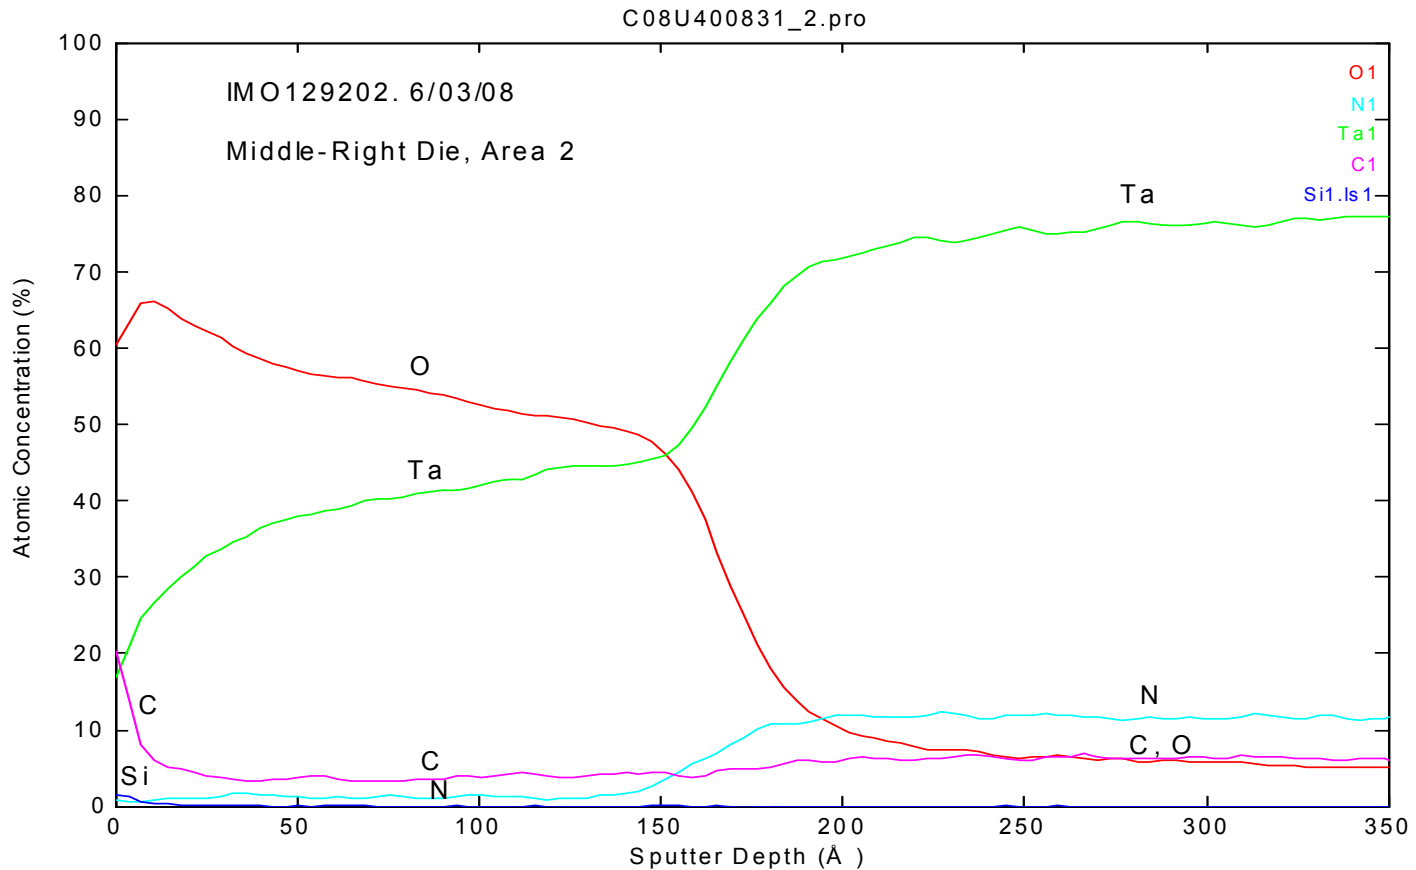
- On Contaminated die, Area 2 (LR_TaBN absorber)
- Very little C at this particular site (Most likely cleaned off by SC1)
