IMEC INPUTS ON BLANK DEFECTIVITY

R. JONCKHEERE

@ IEUVI MASK TWG 16OCT2011

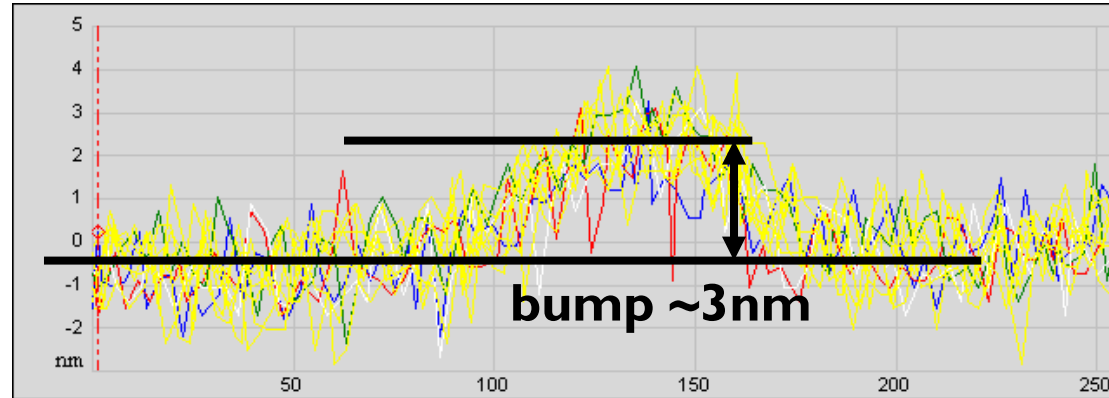
Missers on 1st Gen BI tool

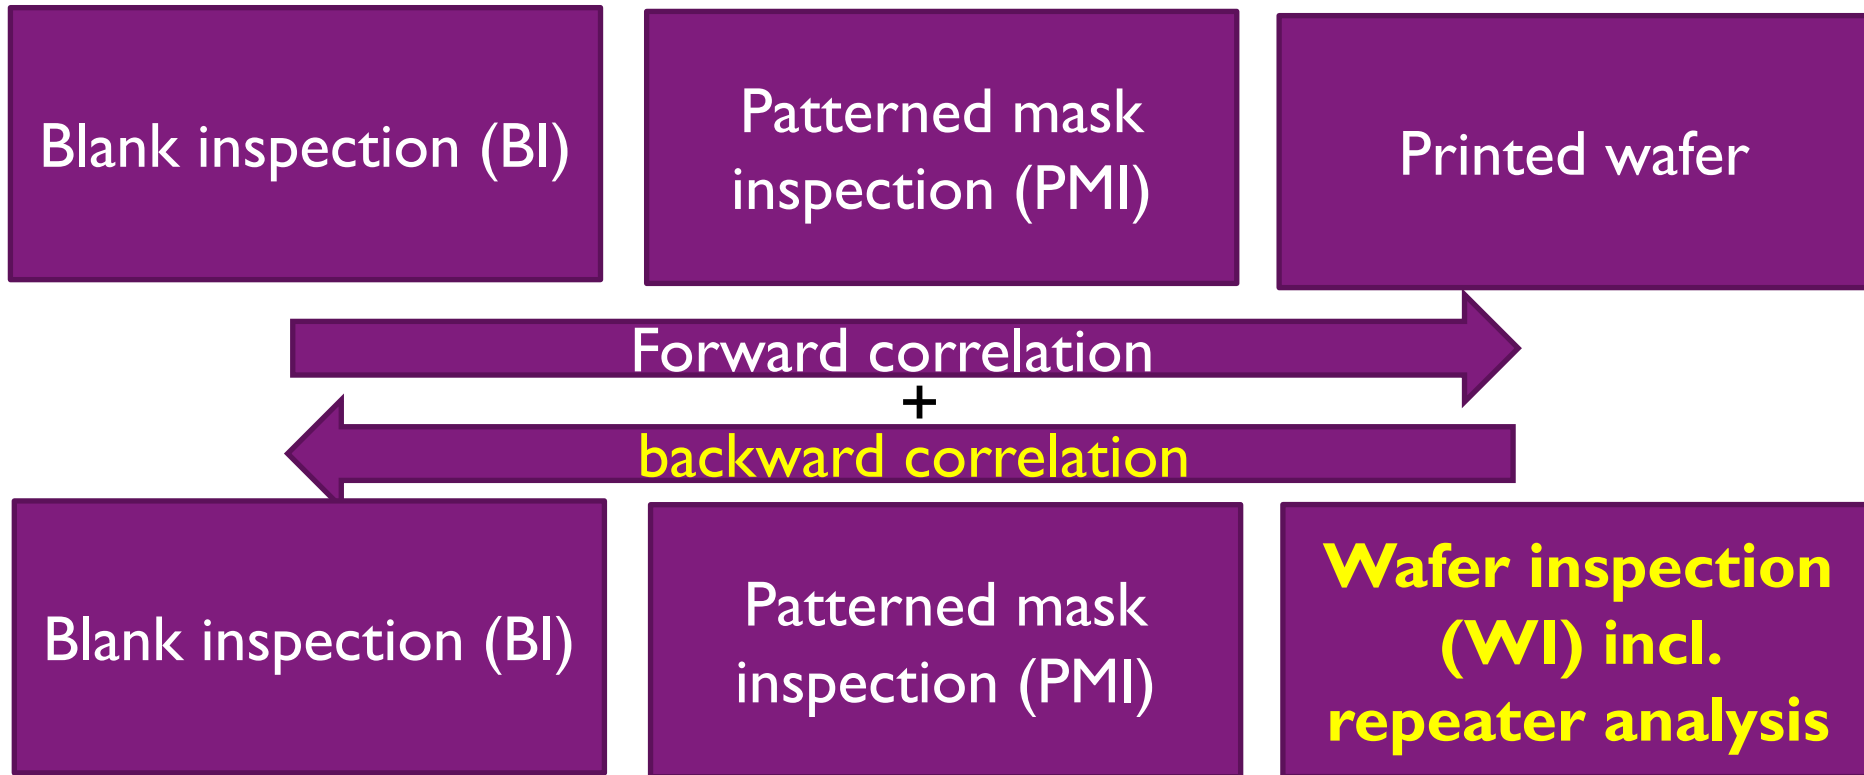
WAY OF WORKING

IMEC has evaluated multiple EUV reticles in terms of defectivity in this way

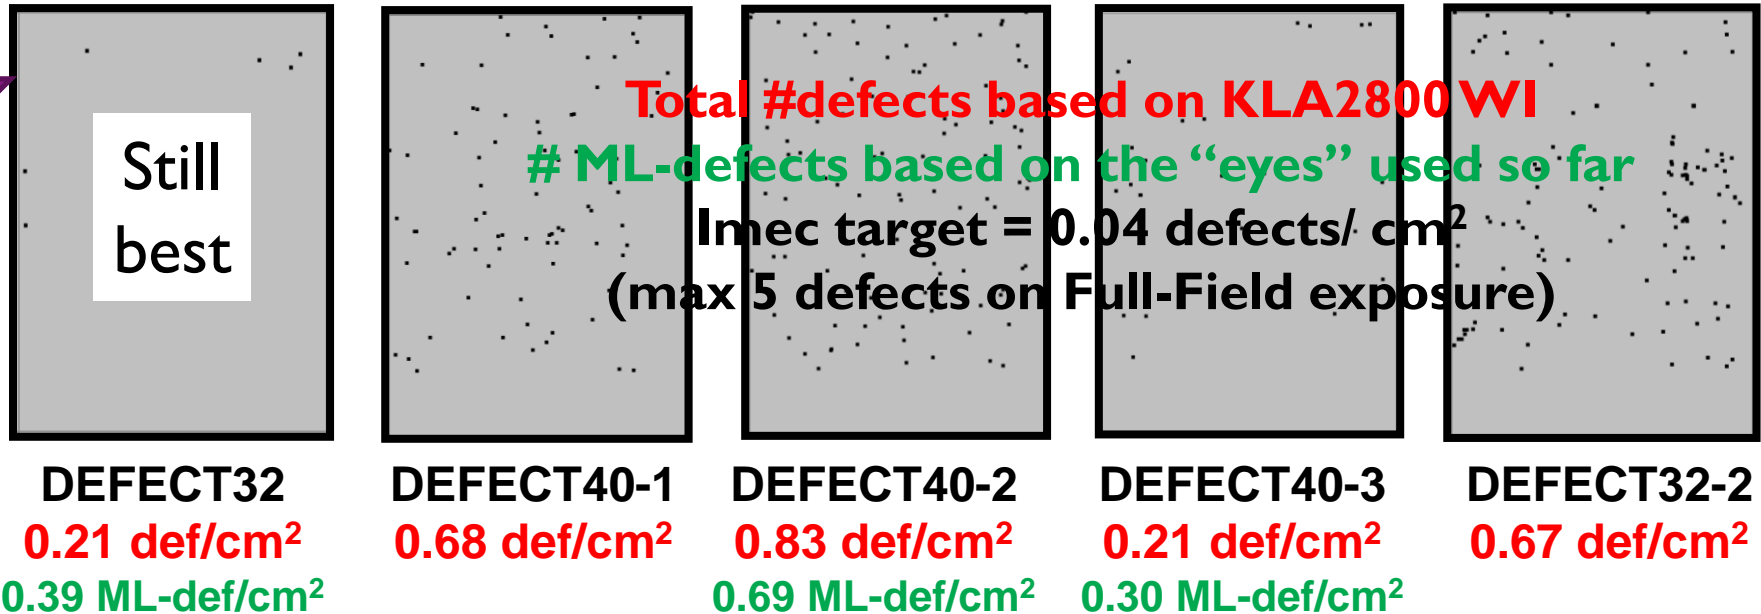
DO WE SEE IMPROVEMENT IN DEFECT DENSITY ?

Our reticles prior to 2009 typically a high count of absorber type defects, severely obscuring the search for natural defects

- In practice we still often see high numbers of absorber type defects and/or particle contamination (although better capability assumed resp. known solution).
- #ML-defects needs to be further decreased.

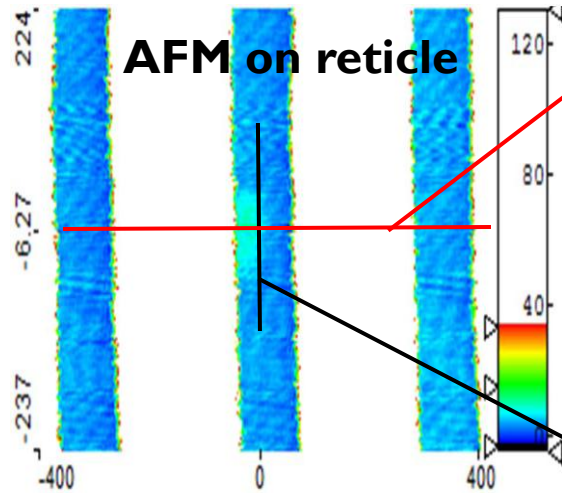
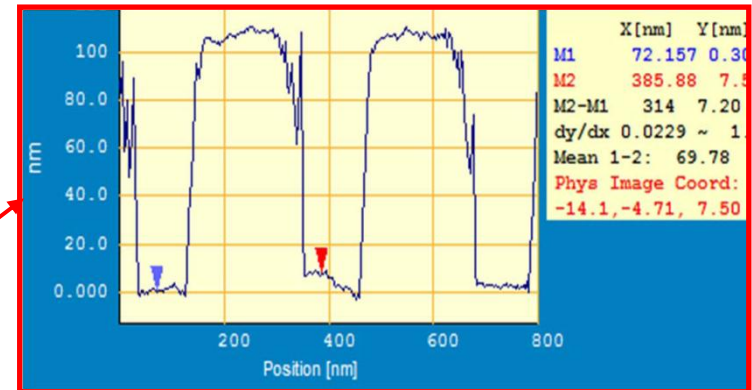
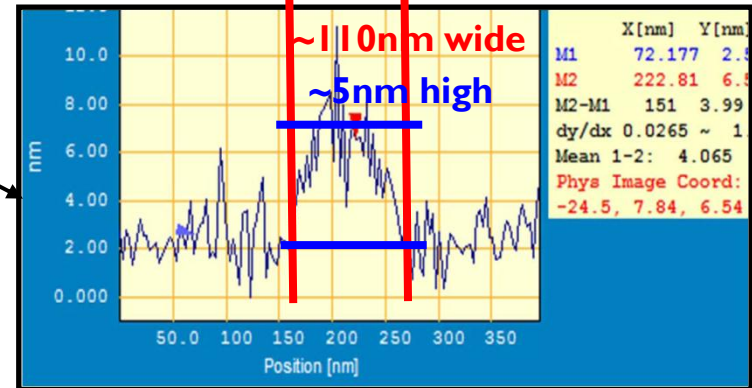
EXAMPLE I OF GEN2 MISER

Sem non-visible on reticle

SEM-review on wafer

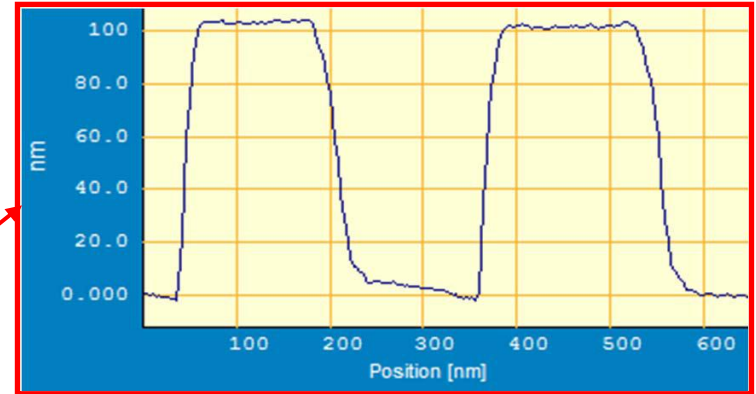
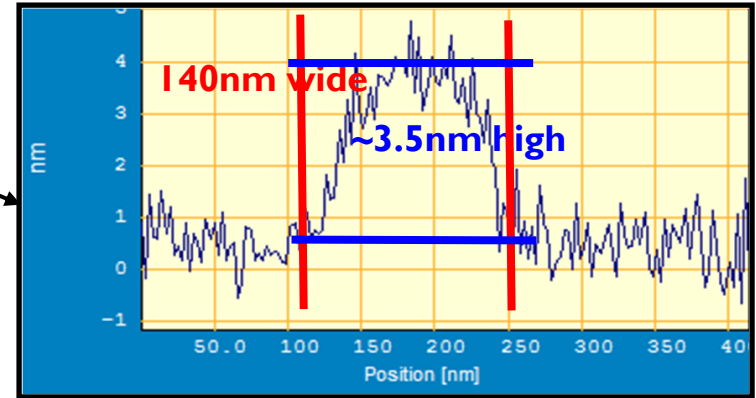
EXAMPLE 2 OF GEN2 MISSE

SEM-review on wafer

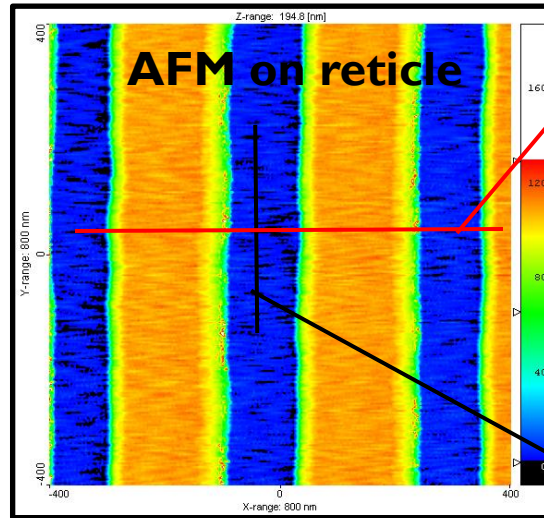
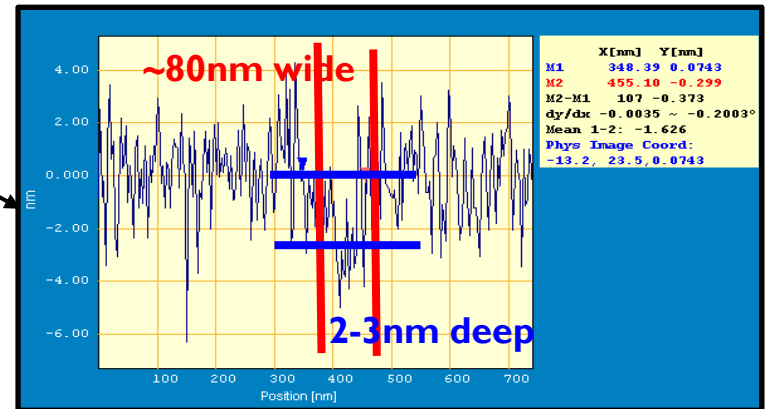
EXAMPLE 3 OF GEN2 MISSE

Noise level starts to limit visualization for shallow defects

SEM-review on wafer

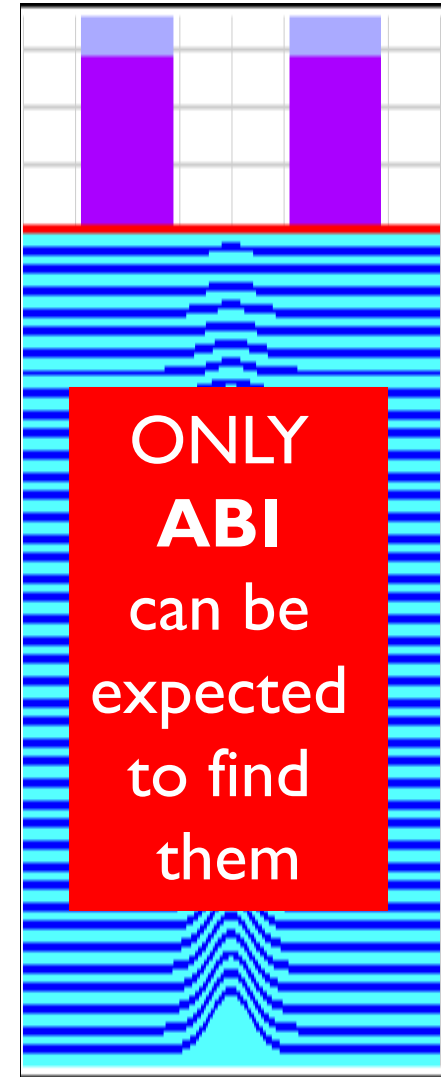
Example:
Bottom height of 6nm already clearly prints at negative focus,, although top height = 0
