# Mask Blank Development IEUVI Mask TWG – 06 Oct 2013

SEMATECH

# Key Defect Challenges for EUV HVM Mask Blanks

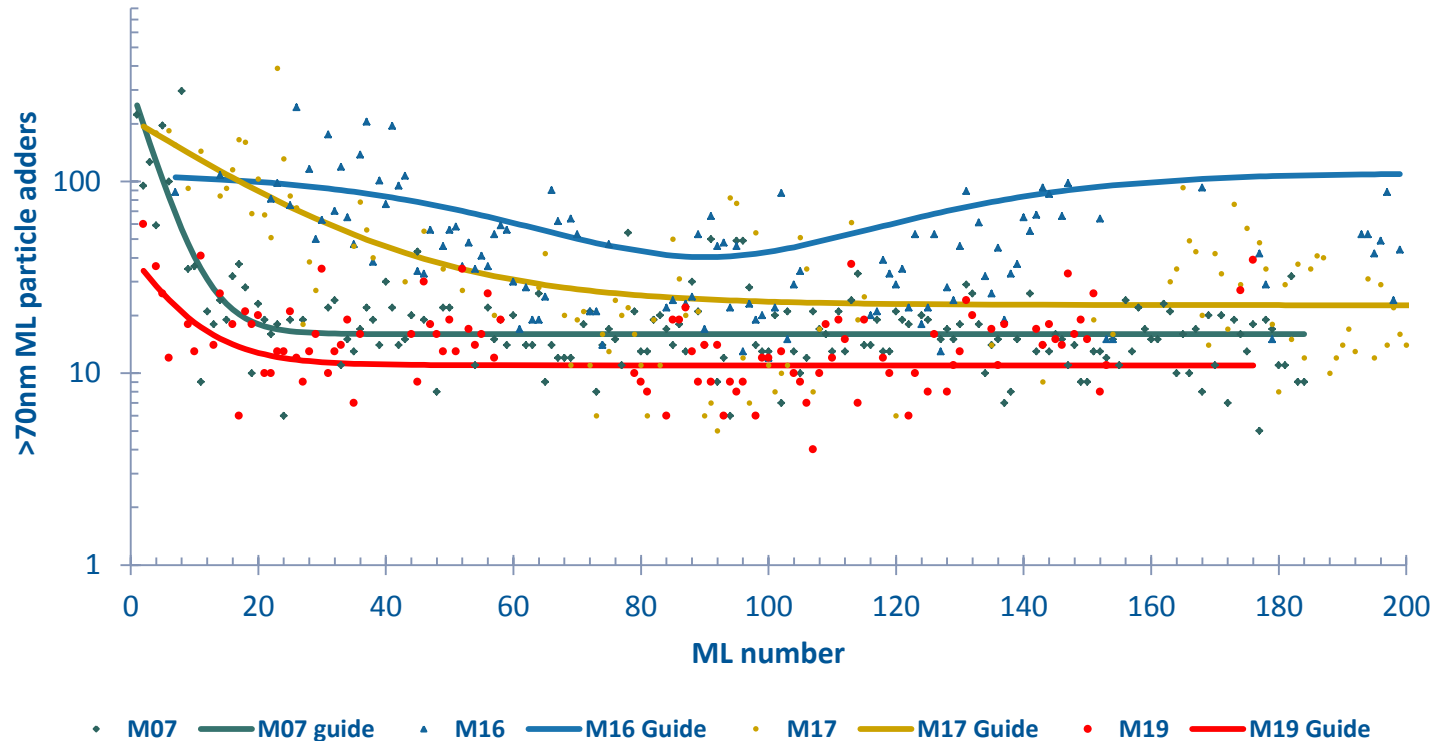
## Multilayer particle adders

- Results of recent process changes introduced by SEMATECH
- Reduction in deposition defect adders (@70nm\*) to improved single digit performance

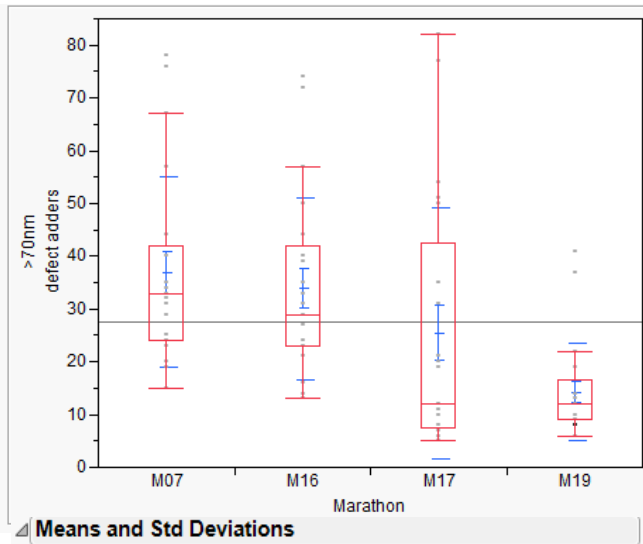
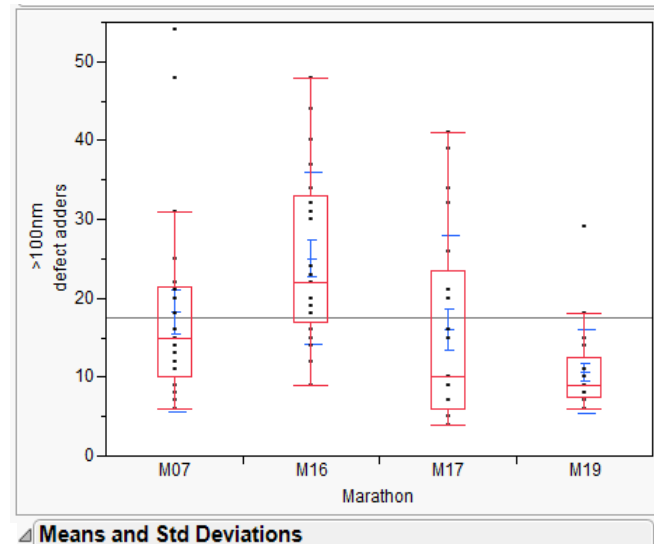
>70nm\* adders

>100nm\* adders

Best run of 21 multilayer blanks from each marathon

- Current deposition run is performing with greater consistency and at lower defect levels
  - Improvement @ 70nm\* in mean and 3sigma
  - Range is narrower
  - Repeatable defect signature between mask blanks
- Major step towards validating that IBD can support HVM manufacturing of EUV mask blanks

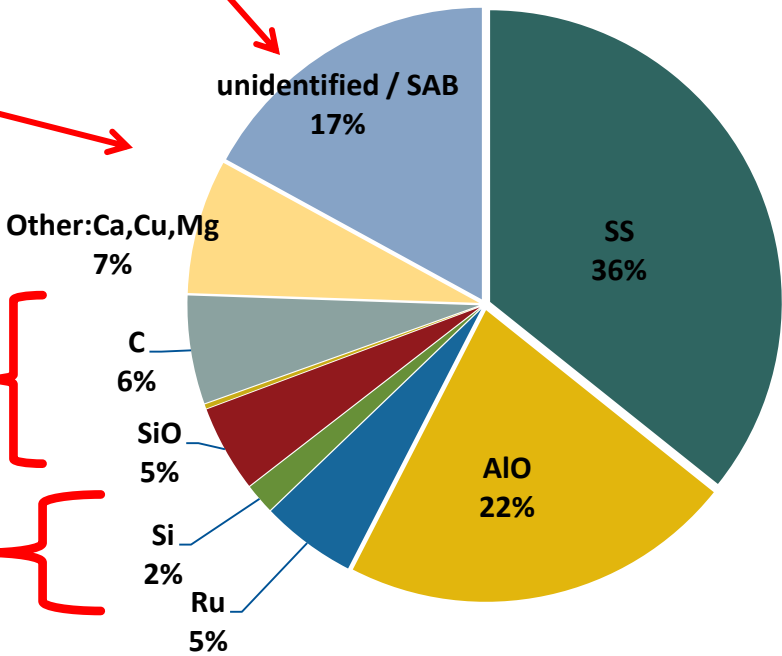
Defects >100nm

core too small to EDS, or indistinguishable from background

Substrate decoration (cleaning residue)

Reticle handling

Deposition target

Mainly from surface of the alumina sandblast-textured SS shields;  
Without these particles, relatively large numbers of 0-defect masks can be yielded!

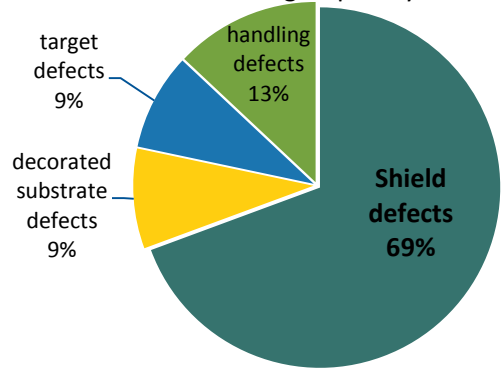
Identified defects grouped by source

Current 2013 defect composition (analysis of 35 mask blanks)

The leading source of "killer" defects remains shield generated.

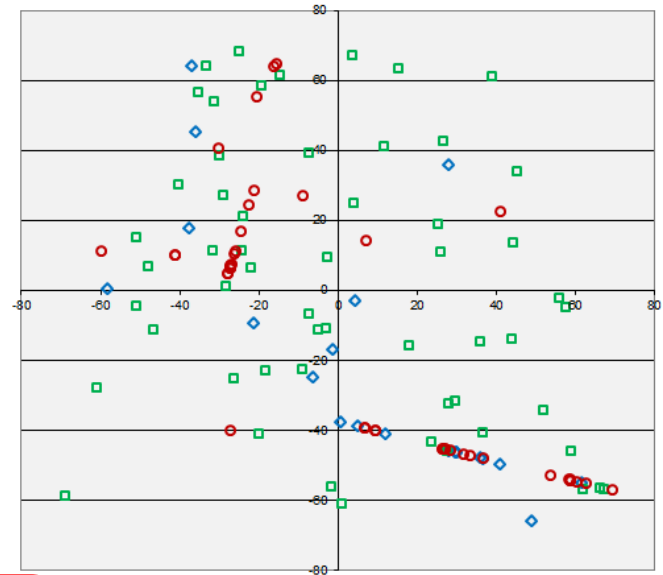
**Deposition**

Defectivity	Pits	Scratches	Particles	Pit+Scr
Substrate @ 40 nm SiO <sub>2</sub> size	5	2	4	7
ML blank @ 43 nm SiO <sub>2</sub> size	56	43	21	99

- Majority of the small sized pits, bumps and scratches do not show up until after decoration by the multilayer deposition
- Current substrate inspection capability not able to detect these defects
  - This gap is not being adequately addressed by the industry
  - Employing a decoration technique to drive improvements but adds cycle time and complexity to isolating defects
- Although small in size the typically high counts eliminate the possibility of mitigation
